This tutorial is designed to help you correct a "carriage off track" issue with your USCutter **MH** or **SC** vinyl cutter.

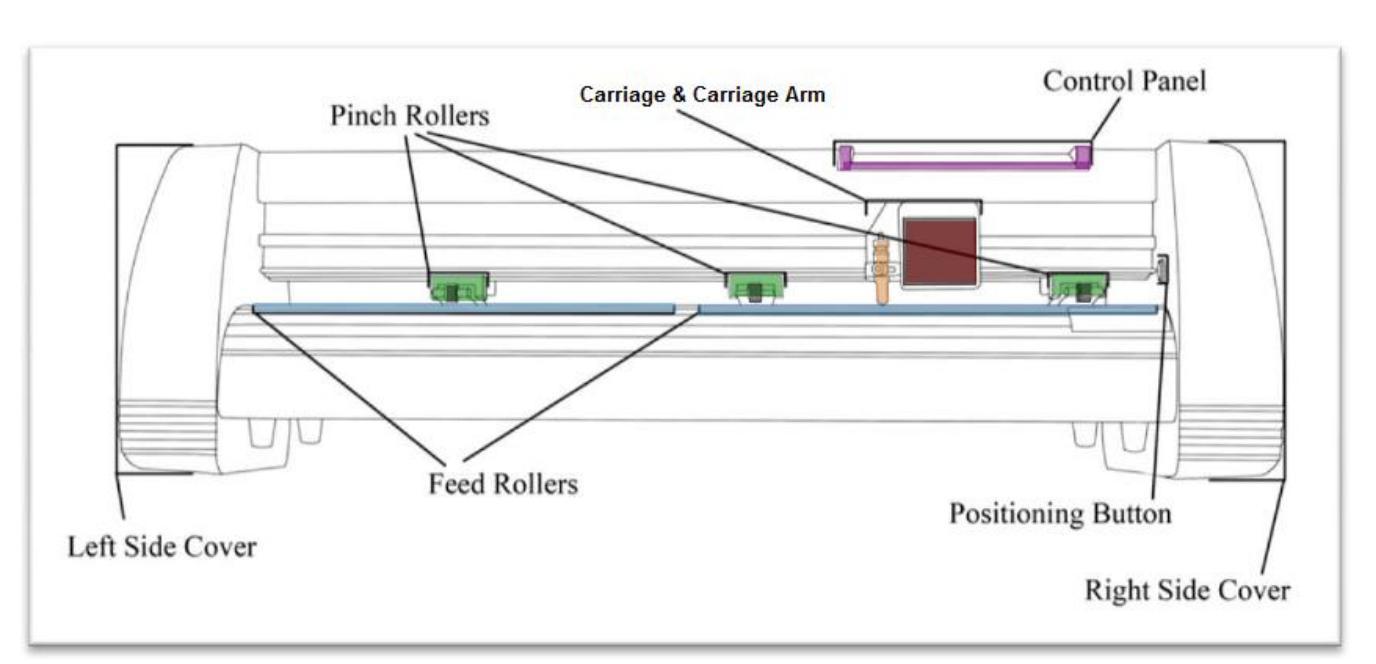
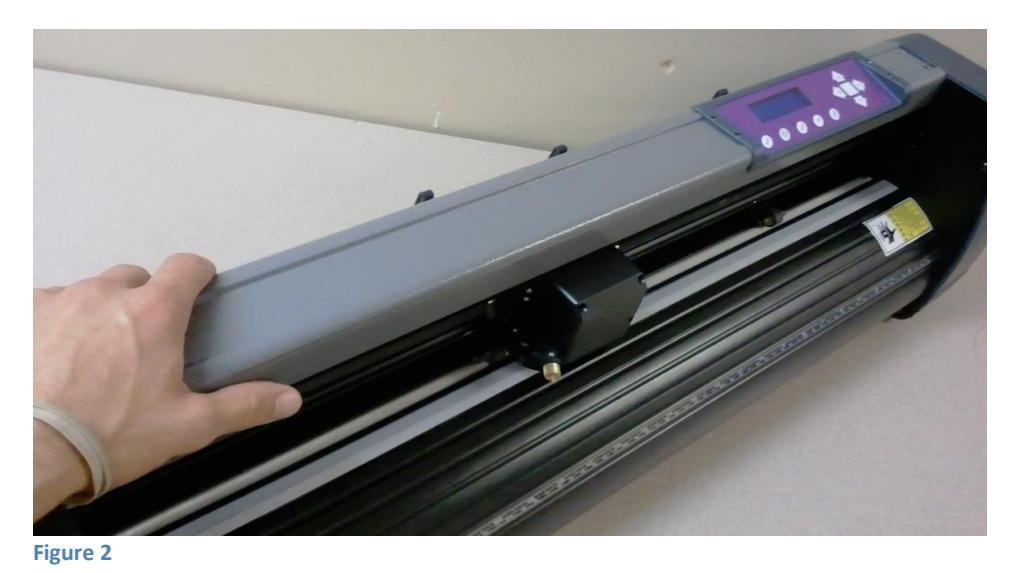
Front View

The carriage houses an electro-magnet which lifts and lowers the blade holder while cutting. The carriage moves back and forth along the rail via three Teflon wheels.

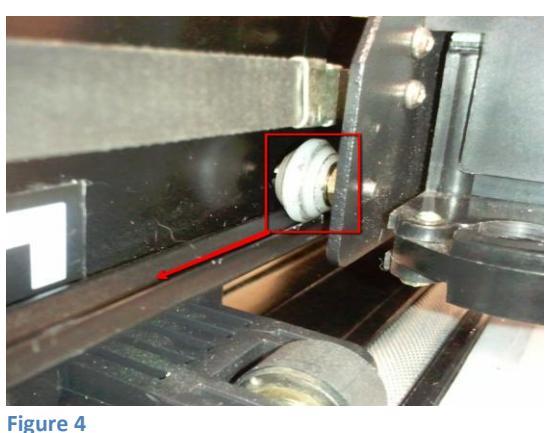
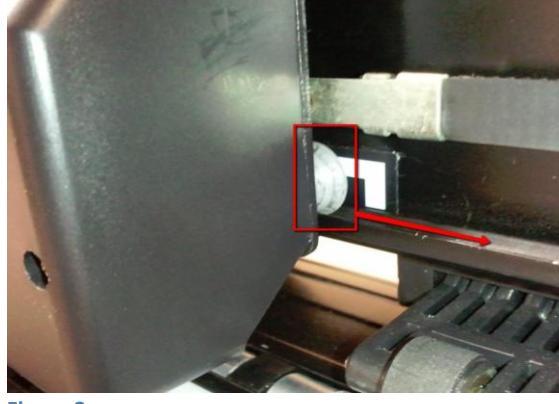
Figure 3

There are two wheels on the bottom of the carriage (left and right) and a single springloaded wheel on top. While you won't be able to see the top wheel, the bottom two wheels are plainly visible behind the backplate as shown in *figure* 3 & 4.

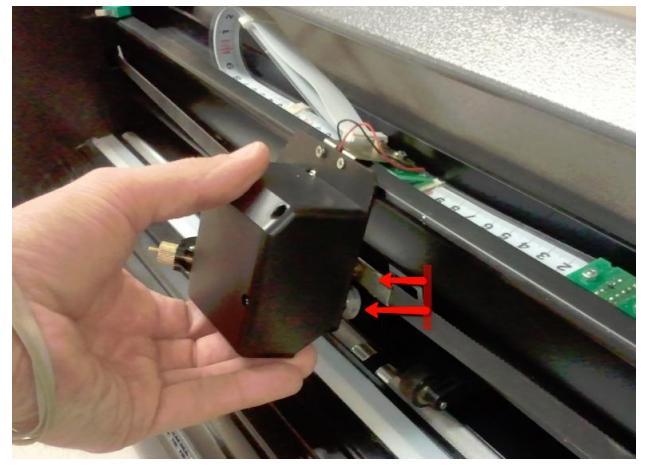
With the cutter turned off, take the carriage by hand and slide it back and forth along the rail. The carriage should slide left and right fairly easily and should not scrape or get stuck at all when moved down the length of the cutter. (if it does get stuck please see STEP 1a.) Now place the carriage in the center of the cutter (if possible) and pull the bottom out towards you. The carriage should not be able to pull away from the rail. If it *does* pull away to any degree (as in *figure* 5), then it is <u>not</u> properly on the track.

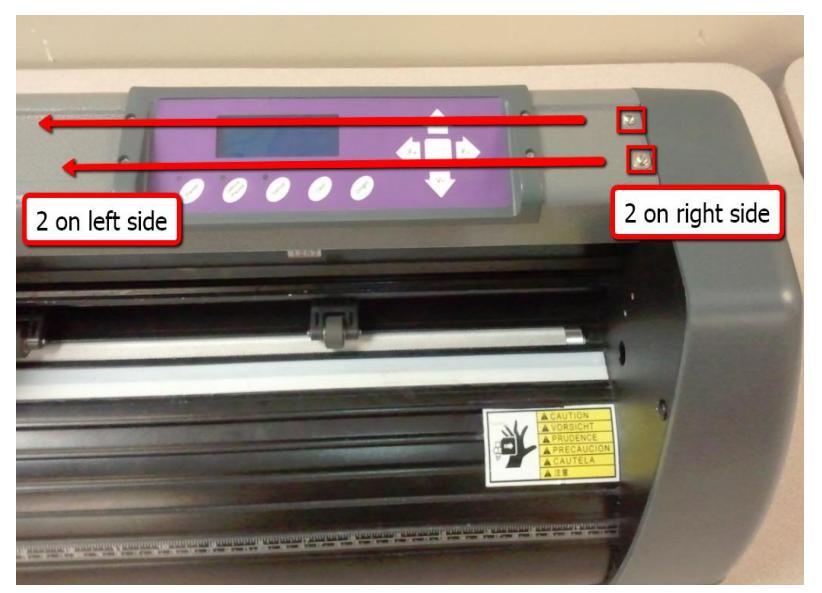
Figure 8

To access the carriage bracket we will need to lift up the top rail from the cutter. This can be accomplished with a small Philips screw-driver. Remove the two silver screws on the far right and far left as pictured in *figure* 8.

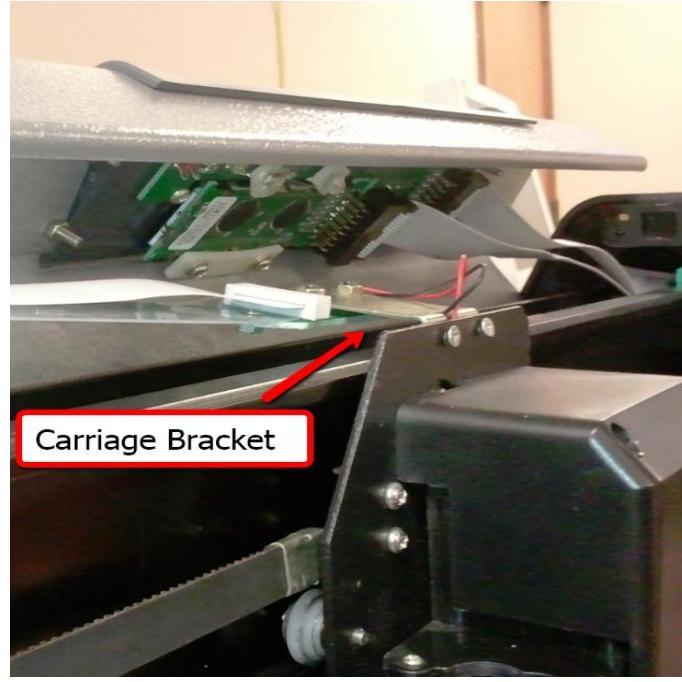
Figure 7

The connecting cables and wires from the motherboard are fed into and under the top rail of the cutter (the part where the menu is located). Often when the carriage is forced off of the track the bracket that holds the ribbon cables to the carriage can get bent up (see *figure* 7). This can lead to contact between the circuit boards under the menu and the carriage bracket, impairing the movement of the carriage.

Gently, bend the metal bracket down such that it can freely clear the circuit board under the menu as well as the small circuit board at the start of the ribbon cable stiffener (measuring tape). Leave the top rail up or off until you are certain that the

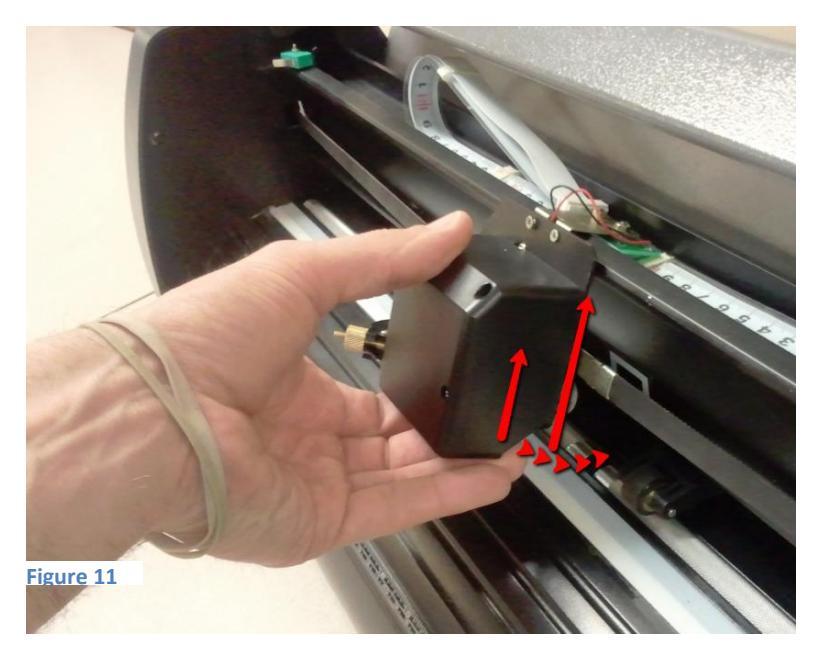
This part is very simple and easily done. Grab the underside of the carriage as shown in *figure* 11.

Push up and in to compress the top wheel spring, then set the two bottom wheels back on the lower track. It can be easy to get only a single lower wheel properly on the track so be sure to check that both sides are back in position. Slide the carriage left and right. It should move with relatively little effort.

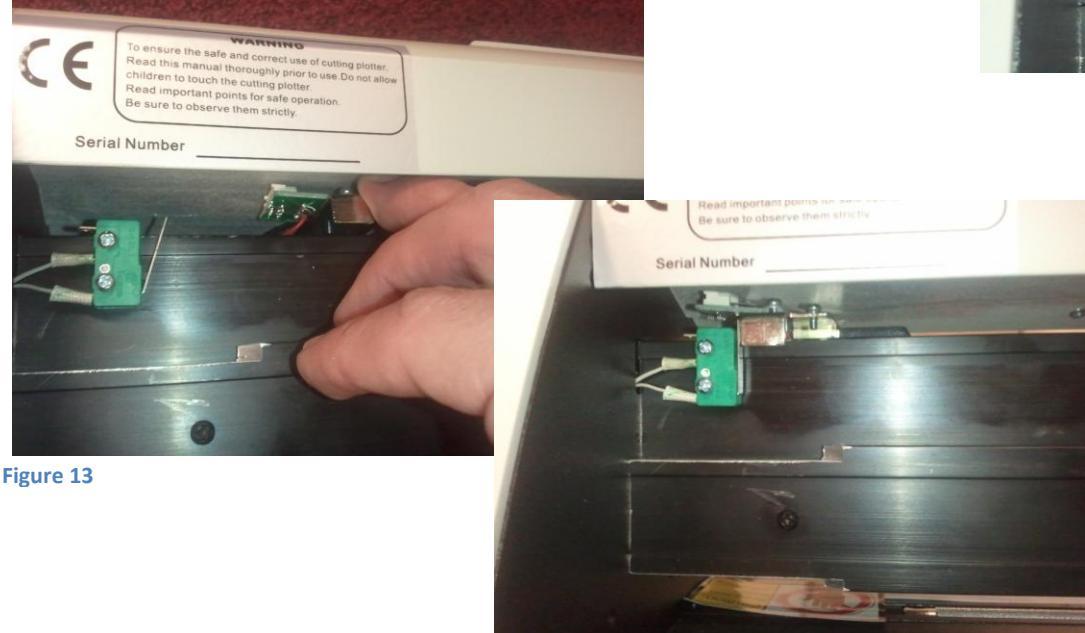
Figure 14

If you have an **SC** vinyl cutter, you'll need to check one final detail. The SC has a carriage bracket much like the MH, however it extends to the back of the machine to make contact with a green limit switch. The limit switch is what tells the cutter when to stop moving the carriage. Often when the carriage is forced off the track on an SC vinyl cutter, that bracket can get bent up causing it to miss the switch.

If the bracket isn't making contact with the switch and the carriage is properly on the track, we'll need to gently bend it back down.
